Manhole Inspection Summary

Manhole # S31II_025MH

Insp Date: **4/6/07 1:50 PM**

Location Address: **1522 MOSHER ST**

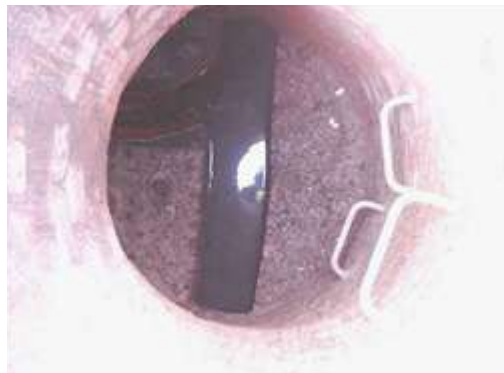
Top View

Bench and Channel debris.

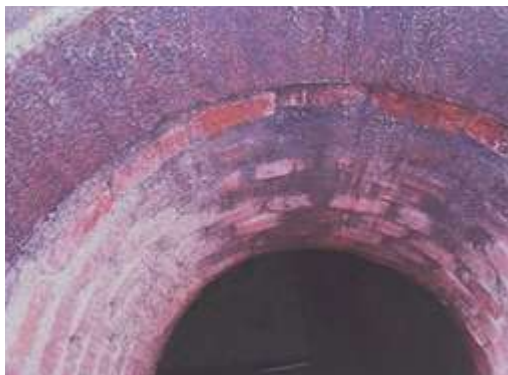
Defect

Frame Offset: **1** (in.) Condition: ☐ Sound ☐ Cracked ☒ **Leaks**

Condition: ☐ Sound ☐ Cracked ☐ Root Intrusion ☐ Loose Brick ☒ **Deteriorated**

Infiltration: ☐ None ☒ **Joint** ☐ Cracks ☒ **Mortar** ☐ Roots ☐ Wall

Frame leaks. Adjustment deterioration and infiltration.

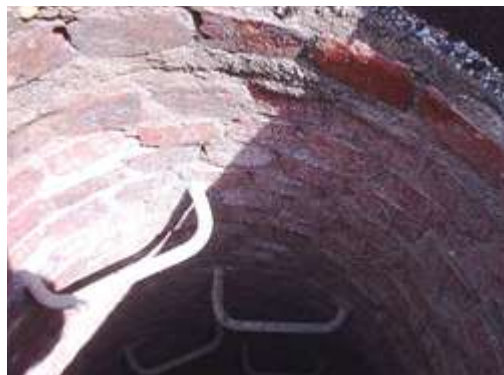
Defect

Frame leaks. Adjustment deterioration and infiltration - other side.

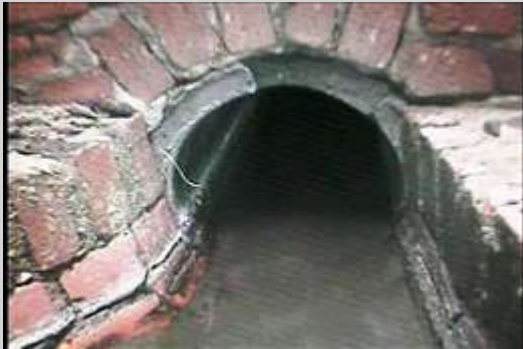
10 in. Circular Gravity Sewer Pipe Out @ 12 O'Clock

Channel deterioration.

Deposits: ☐ None ☐ Mud ☐ Sludge ☐ Debris ☒ **Grease**

Infiltration: **Evidence** Pipe Seal Cond: **Broken**

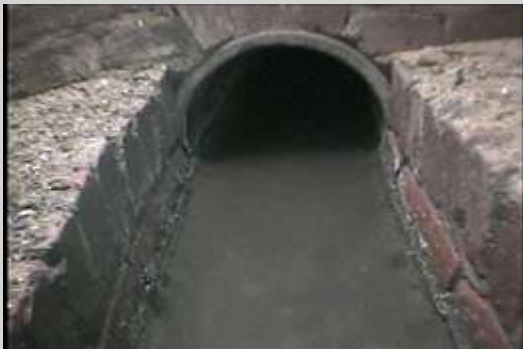
10 in. Circular Gravity Sewer Pipe In @ 6 O'Clock

Deposits: ☐ None ☐ Mud ☐ Sludge ☐ Debris ☒ **Grease**

Infiltration: **None** Pipe Seal Cond: **Cracked**

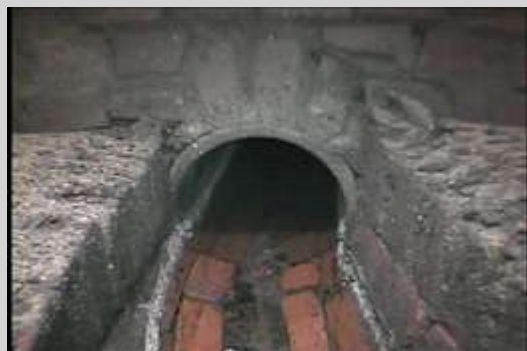
Pipe In @ 9 O'Clock

Deposits: ☐ None ☐ Mud ☐ Sludge ☐ Debris ☒ **Grease**

Pipe Seal Cond: **Cracked**
